Manhole Inspection Summary

Manhole # S47K__002MH

Location Address: **2304 foster ave**

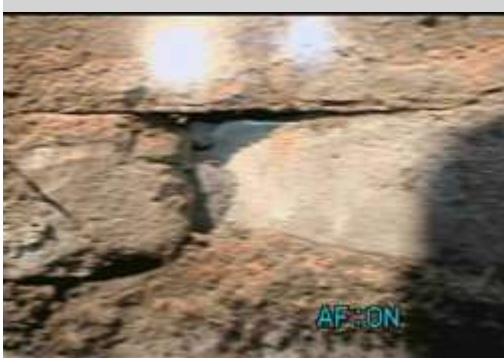
Defect 2

Condition: ☐ Sound ☒ **Cracked** ☐ Root Intrusion ☐ Loose Brick ☒ **Deteriorated**

frame adj, Chimney cracked and deteriorated

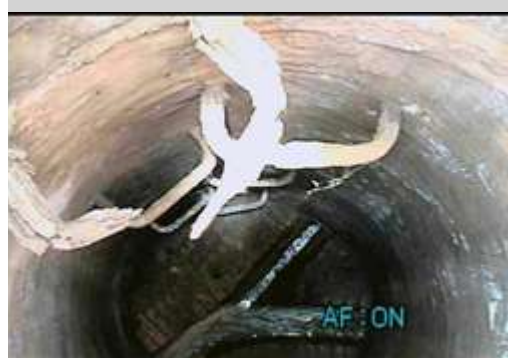
Defect 1

Count: **6** Missing: **1** ☒ **Corroded**

Missing/Corroded steps

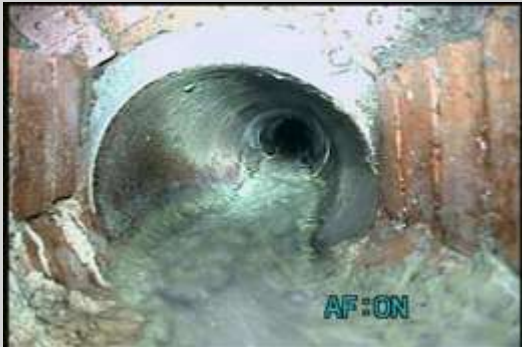
12 O'Clock Outflow

10 in. Circular Gravity Sewer
Pipe Out @ 12 O'Clock

Infiltration: **None** Pipe Seal Cond: **Unknown**

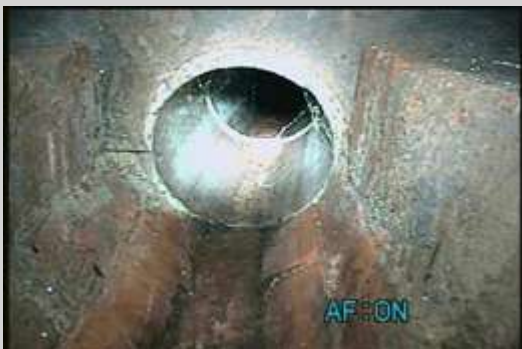
6 O'Clock Inflow

8 in. Circular Gravity Sewer
Pipe In @ 6 O'Clock

Infiltration: **None** Pipe Seal Cond: **Unknown**

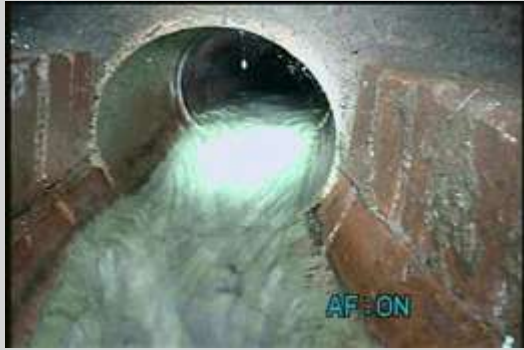
8 O'Clock Inflow

8 in. Circular Gravity Sewer
Pipe In @ 8 O'Clock

Infiltration: **None** Pipe Seal Cond: **Unknown**
